Manhole Inspection Summary

Manhole # S25AA_025MH

Insp Date: **11/26/07 1:07 PM**

Location Address: **801 ARLINGTON-FREMONT**

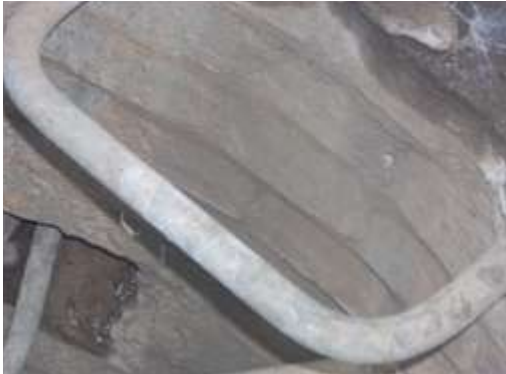
Defect 3

Corbel Material: **Brick** ☐ Parged Type: **Concentric/Eccentric**

Condition: ☐ Sound ☐ Cracked ☐ Root Intrusion ☐ Loose Brick ☒ **Deteriorated**

Infiltration: ☐ None ☐ Joint ☐ Cracks ☐ Mortar ☐ Roots ☒ **Wall**

CORBEL INFILTRATION NEXT TO STEP

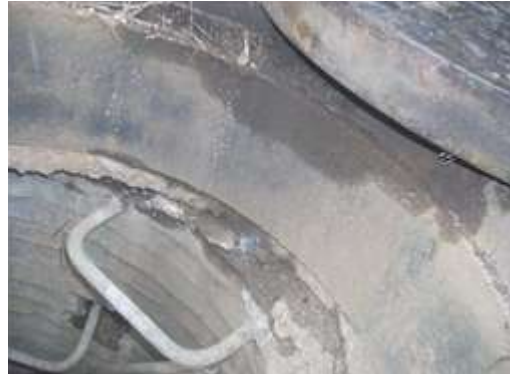
Defect 2

Chimney / Frame Adjustment ☒ Exists Material: **Brick and Concrete** ☐ Parged Height: **3** (in.)

Condition: ☐ Sound ☐ Cracked ☐ Root Intrusion ☐ Loose Brick ☒ **Deteriorated**

CHIMNEY DETERIORATION

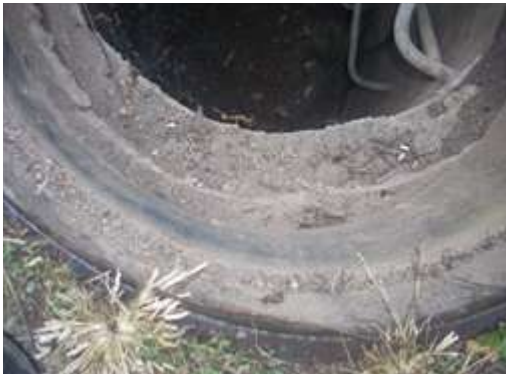
Defect 1

Frame Offset: **5** (in.) Condition: ☒ Sound ☐ Cracked ☐ Leaks

FRAME OFFSET

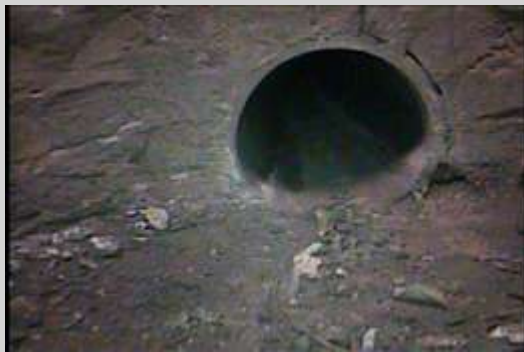
12 O'Clock Outflow

8 in. Circular Gravity Sewer
Pipe Out @ 12 O'Clock

Pipe Height: **8.4** (in.) Rod and Bar (Angled)

Pipe Material: **Clay** ☐ Pipe Lined

Invert Depth: **6.71** (ft.) Flow Characteristics: **None**

Deposits: ☒ None ☐ Mud ☐ Sludge ☐ Debris ☐ Grease

Infiltration: **None** Pipe Seal Cond: **Sound**
